# Test Report

| Product | <b>Pergola Awning</b> |
| Designation | <b>System: PERGOLA BIOCLIMATIC</b><br><b>Shipping name: FULL STANDING BIOCLIMATIC PERGOLA</b> |

Resistance to water accumulation - exterior blind

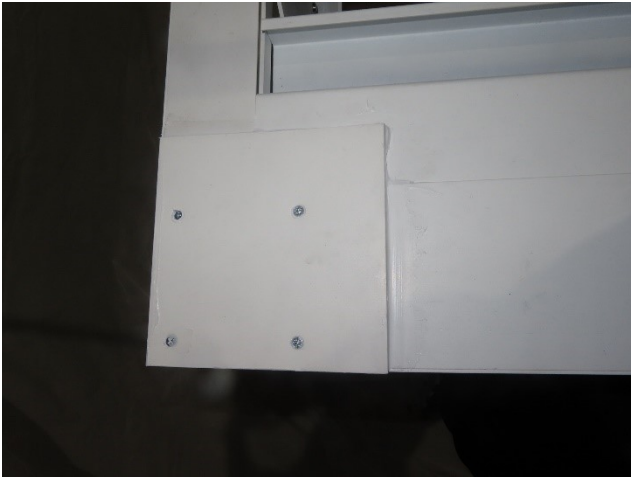
Picture 3 Corner of test specimen

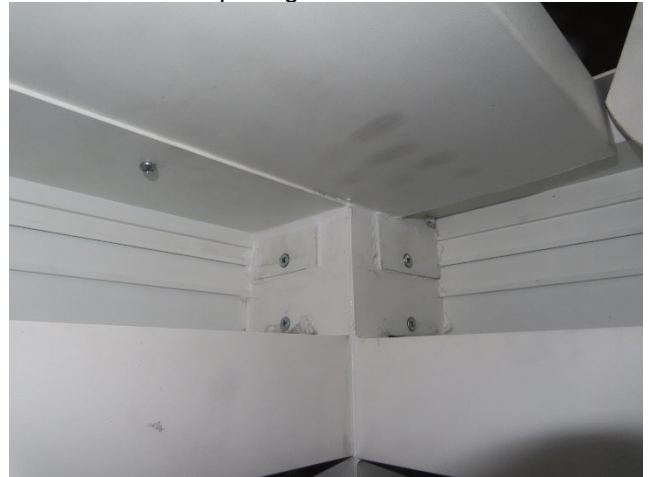
Picture 4 Corner of test specimen

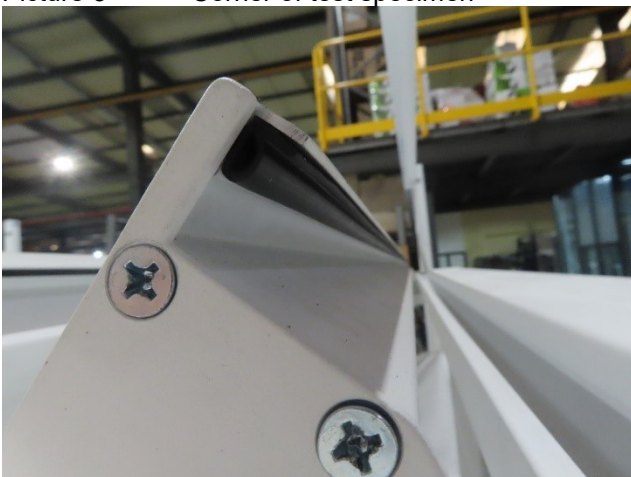
Picture 5 Louvre sealing gasket

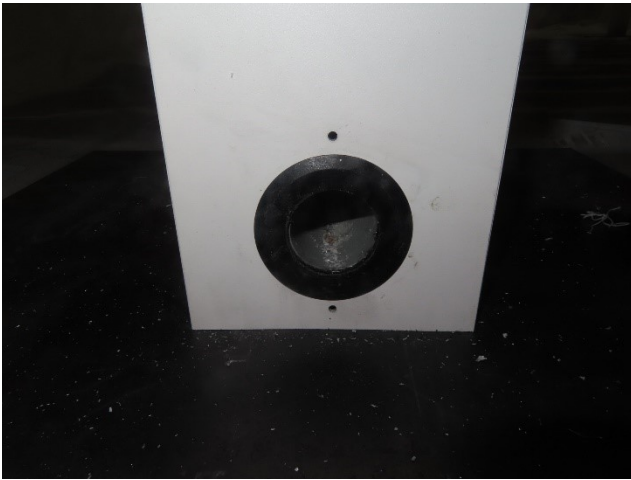
Picture 7 Drainage system
